**Mandatory
Service Bulletin**

**MAIN ROTOR BLADE ABRASION STRIP
DAILY INSPECTION REQUIREMENTS**

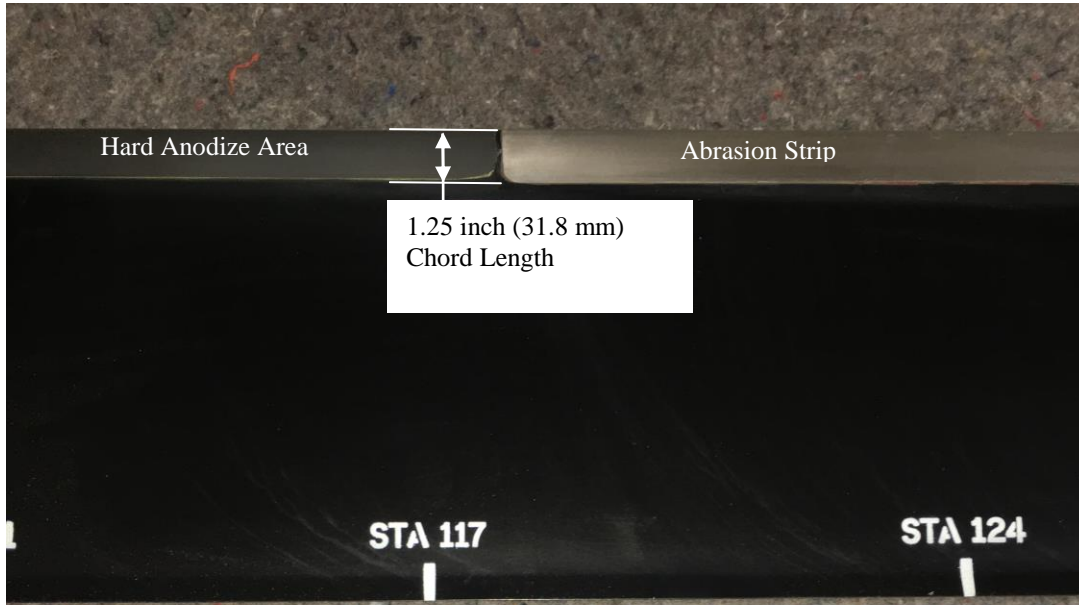
Figure 1 – 1.25 inch (31.8 mm) Chord Abrasion Strip

Subject
to this
Mandatory
Service
Bulletin

- 1) Determine which Chord Length Abrasion Strip is present on the subject blade and Total Time Since New (TTSN) or since Abrasion Strip Replacement to determine if this Mandatory Service Bulletin is applicable. Reference **Figure 1** and **Figure 2** on Page 2.
